Reliability Assessment and Activation Energy Study of Au and Pd-Coated Cu Wires Post High Temperature Aging in Nanoscale Semiconductor Packaging

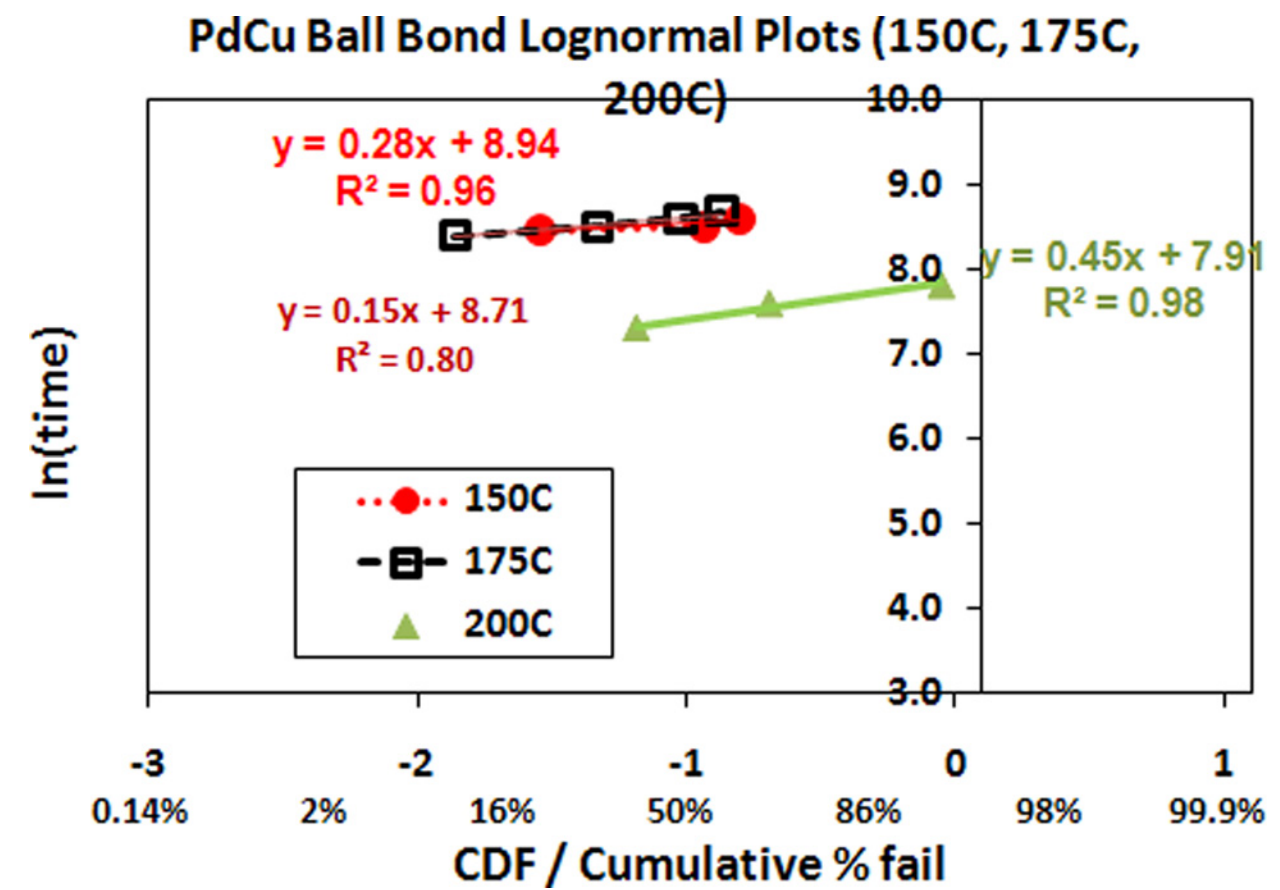
Fig. 2 High temperature aging (150 °C, 175 °C, 200 °C) lognormal plots and its characteristics of PdCu used in 110 nm device FBGA 64 package

packaging. Moisture reliability of bare Cu wire is identified as key technical barrier of Cu wire deployment in nanoelectronic packaging. Cu ball bond open is one of the bonding failures attributed to interface CuAl IMC microcracking [1–3,11,19,20]. Figure 2 indicates the wearout reliability lognormal plot of PdCu ball bond. In our evaluation, PdCu lognormal plots higher reliability margin in HTSL aging tests (Table 1).

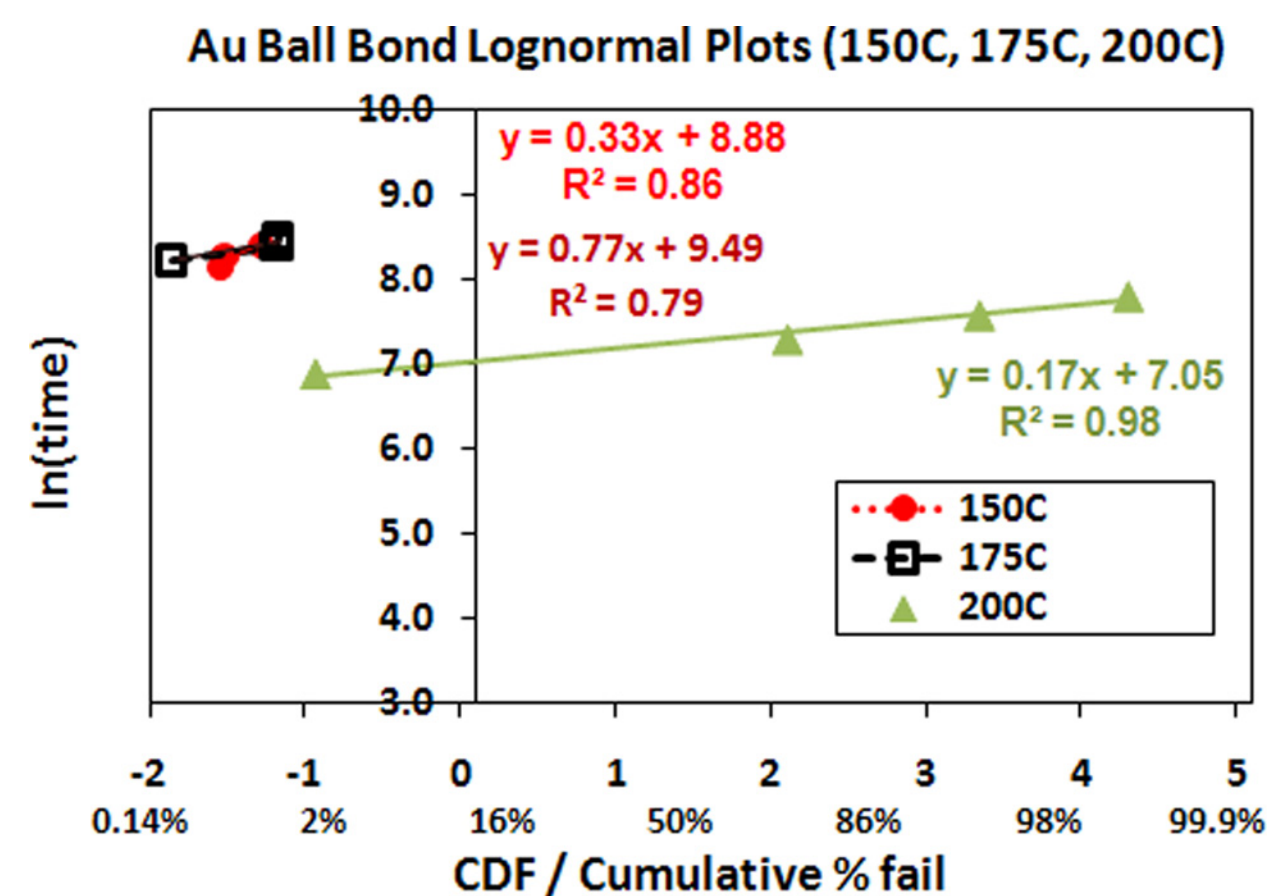
Fig. 3 High temperature aging (150 °C, 175 °C, 200 °C) lognormal plots and its characteristics of Au used in 110 nm device FBGA 64 package

Figure 3 reveals wearout reliability plots fitted to lognormal distribution of Au ball bond. PdCu ball bonds shows better aging hours to failure compare to Au ball bonds on 110 nm device, FBGA 64 package. This is owing to the slower PdCu-Al IMC formation compares AuAl IMC formation and results in better long term reliability [6,9,20–22].

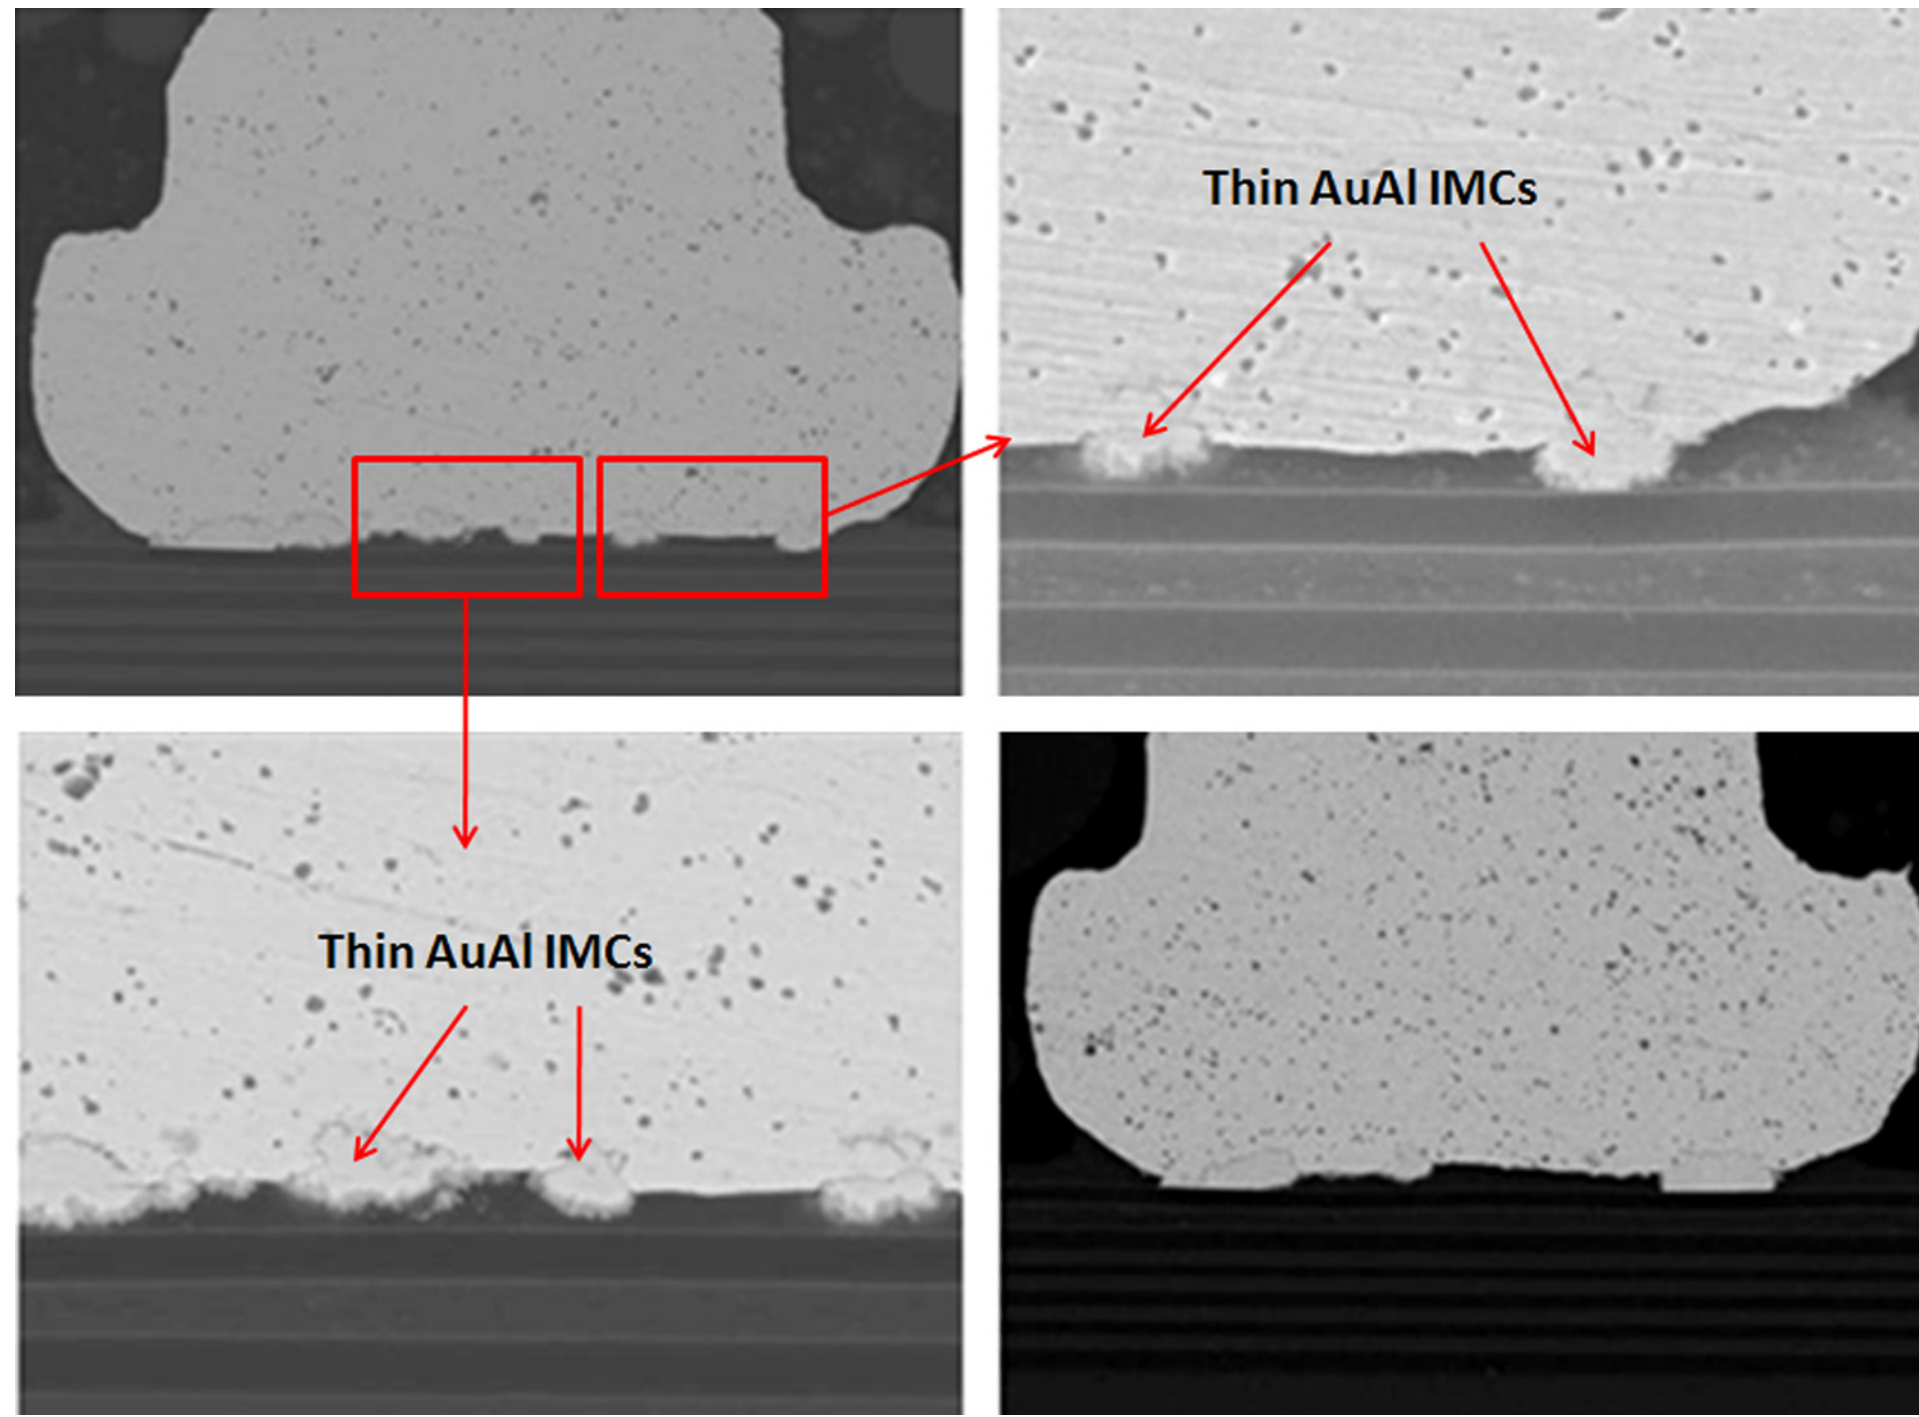
Fig. 4 SEM images show thin AuAl IMC formation on as bonded stage of Au wirebond package prior to reliability stress

3.2.1 Effects of Wire Type Used in Nanoelectronic Packaging. The effect of wire type used in nanoelectronic device packaging affects the long term reliability of semiconductor packages. The wearout failure mechanisms of CuAl interface oxidation and microcracking (which induce Cu ball bond opens) are mainly owing to CuAl IMC interface oxidation [1,5,7,8,11,12,16,19]. While the AuAl IMC interfacial oxidation and Kirkendall micro voiding are widely reported by industrial and academic researchers [9,21,23,25]. The as bonded stage of Au ball bonds are observed with thin AuAl IMC formation and no Kirkendall micro voiding is found in microstructure analysis (see Fig. 4).

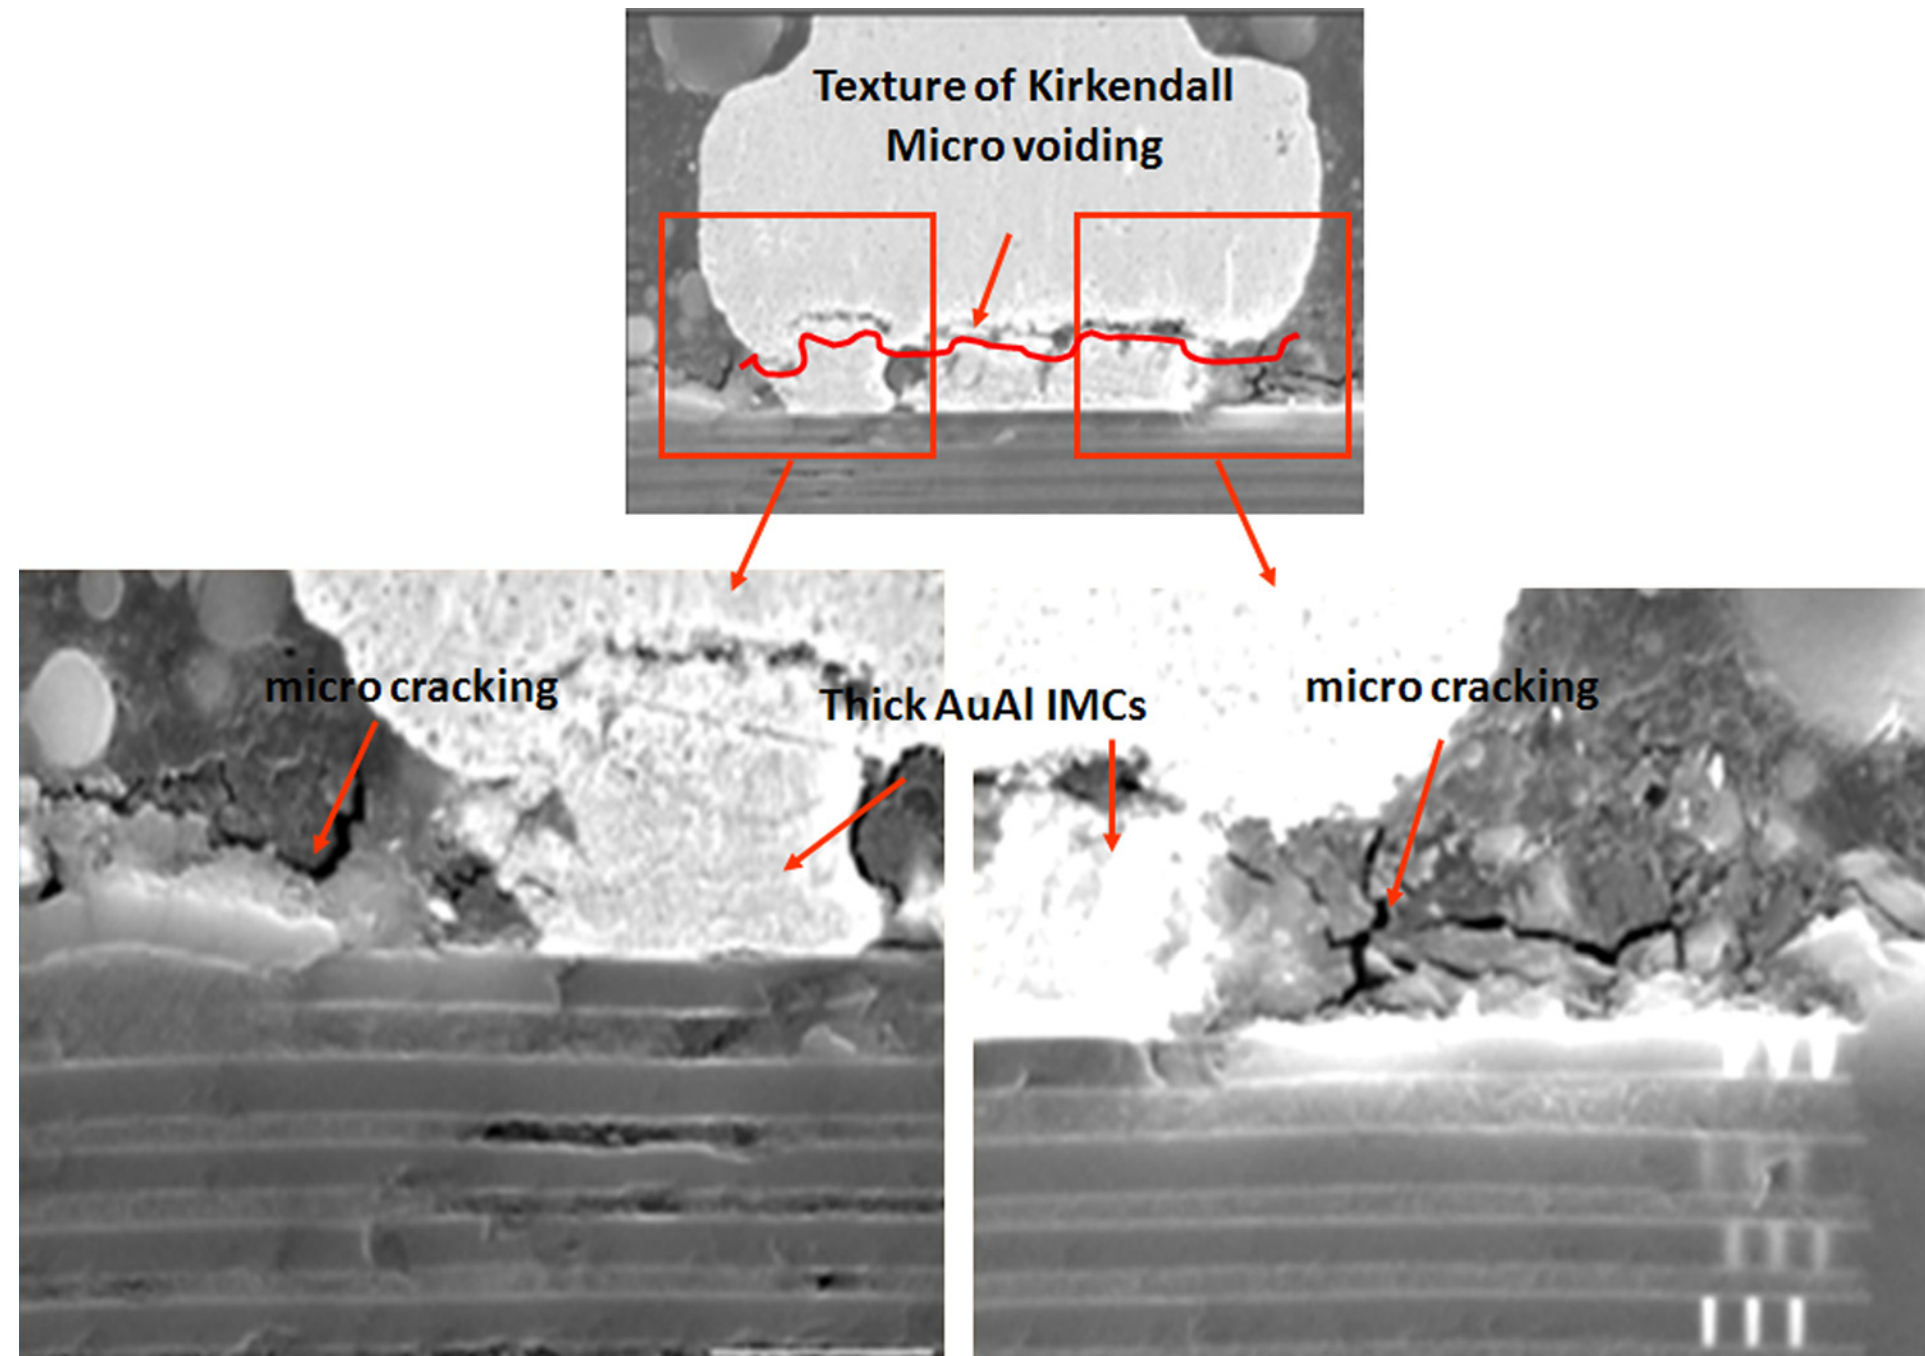
In our study, the typical AuAl IMC interface oxidation and microvoiding is indicated in Fig. 5 after 200 °C 1500 h aging stress. The whole fine line AuAl IMC microcracking and microvoiding occurs along the whole AuAl IMC interface. Thicker AuAl IMC layer is formed beneath Au ball bond and micro cracking is observed after 1500 h of HTSL test. Kirkendall micro voiding is found beneath Au ball bond in cross-section analysis and further package decapsulation is conducted to confirm the Kirkendall micro voiding event (as shown in Fig. 6).

Fig. 5 Typical Au ball bond IMC voiding and cracks post extended HTSL stress (1500 hr, 200 °C). Thicker AuAl IMC is formed with sign of Kirkendall microvoiding, microcracking beneath Au ball bond after long duration of HTSL test.

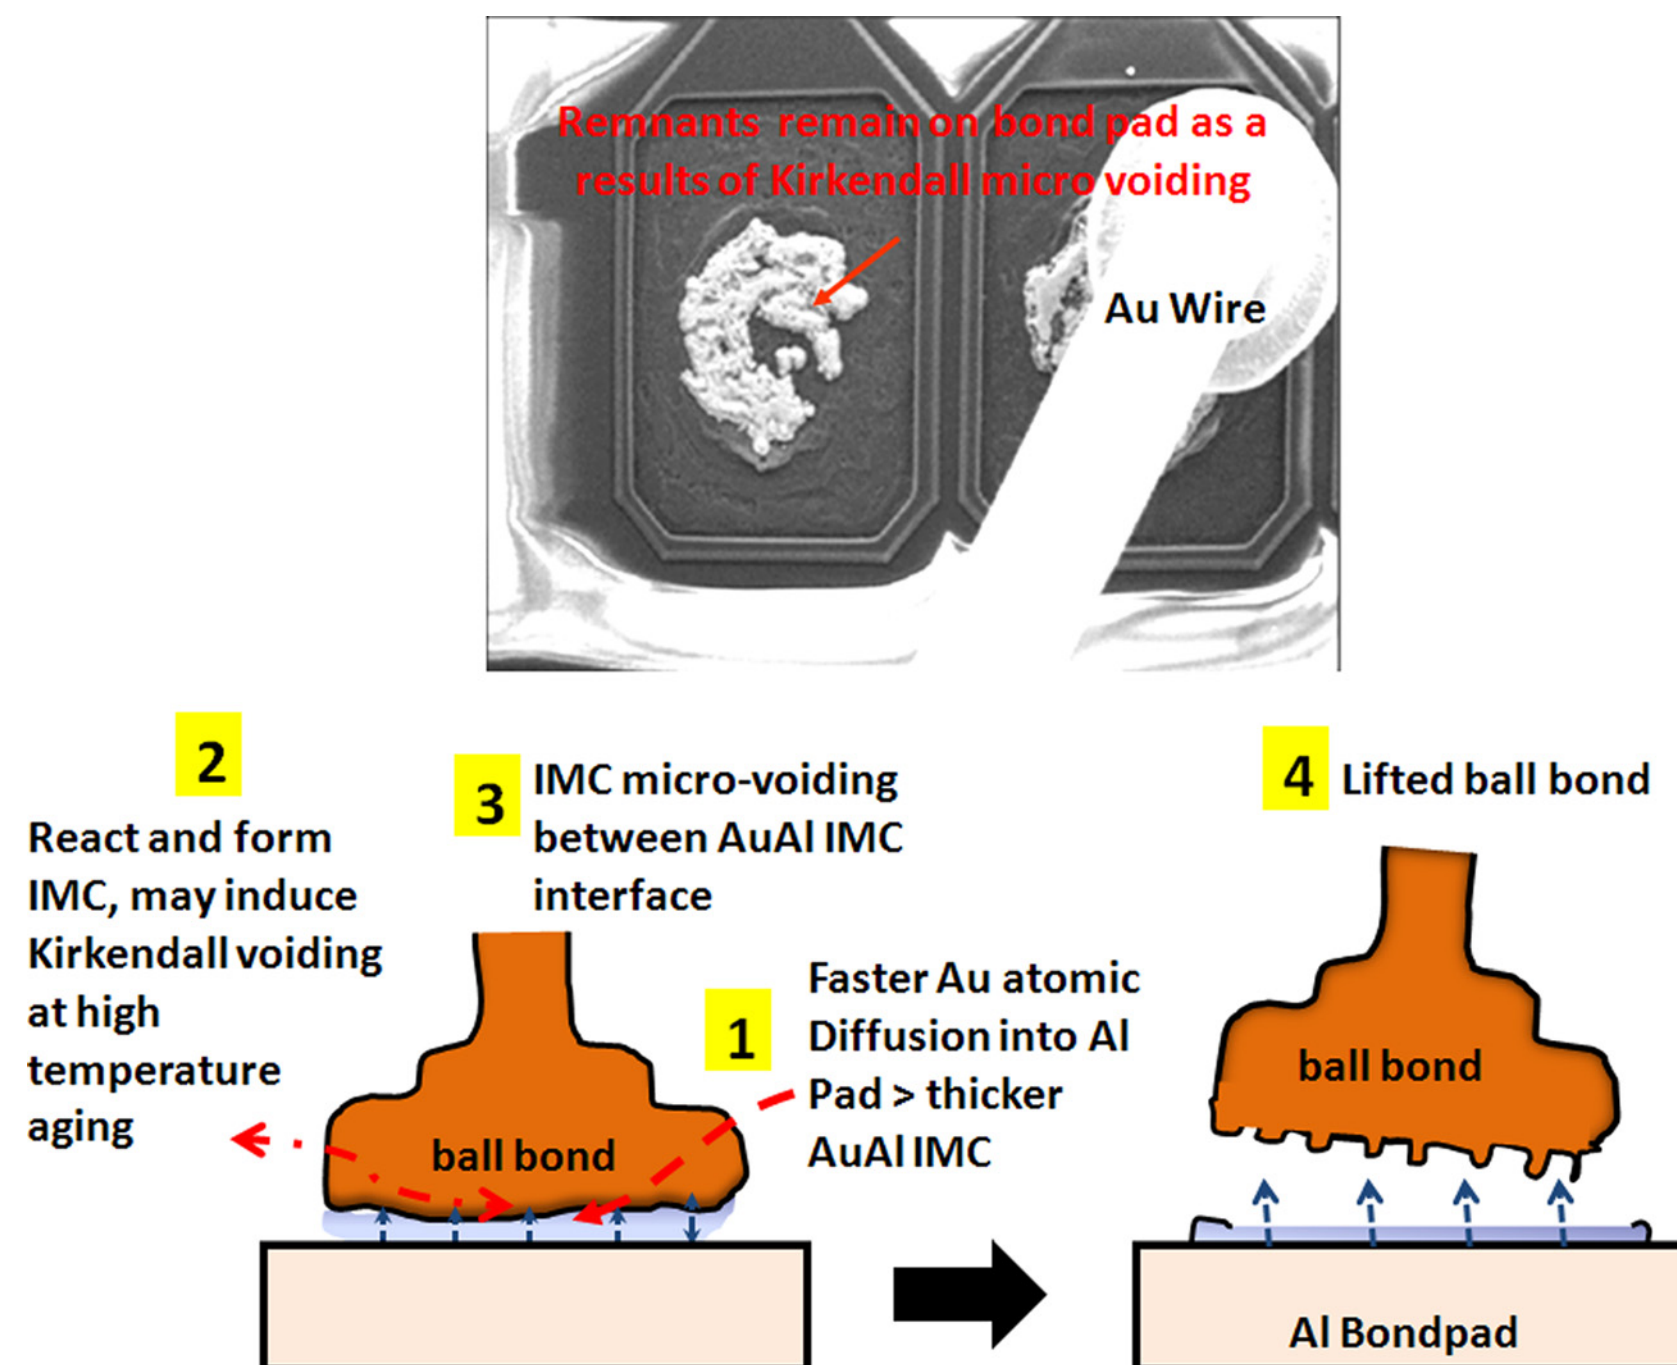
Fig. 6 Proposed failure mechanism of AuAl Kirkendall micro voiding and caused lifted ball bond

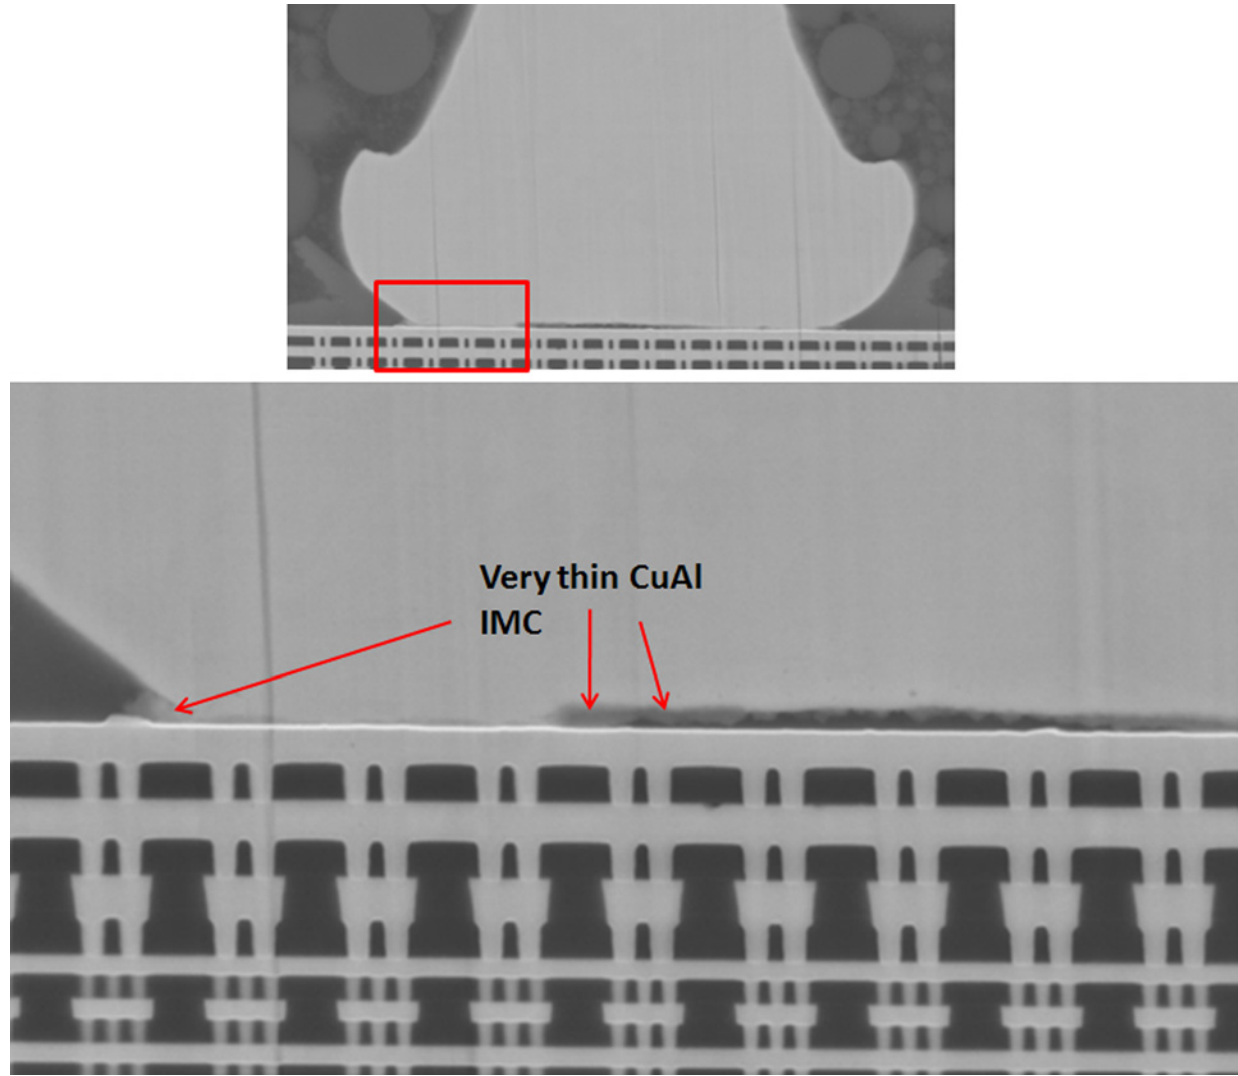
For Cu ball bond as bonded microstructural analysis, we found almost no CuAl IMC formation and no signature of micro cracking beneath Cu ball bond (see Fig. 7) on unit prior to HTSL reliability testing. CuAl IMC micro cracking and micro voiding are formed after extended duration of 1500 h HTSL test (as indicated in Fig. 8). Kirkendall micro voiding event is not found in our micro structural analysis. Figure 8 illustrates the typical HTSL 200 °C 1500 h aging and its CuAl IMC interface oxidation and microcracking most probably attributed to Oxygen attacking the edge of Cu ball bond region. Usually the Pd coated layer will be dissolved during CuAl Pd IMC formation in PdCu ball bonds. Oxygen gas will penetrate into the edge of Cu ball bond and induce dry oxidation of CuAl IMC (in this case the majority of IMC are Cu_9Al_4 and $CuAl_2$) as shown in Eqs. (2) and (3) [3]. Dry oxidation will produce CuO which is resistive layer in CuAl interface (as shown in Eq. (1)).

Fig. 7 SEM images show very thin CuAl IMC formation on as bonded stage of Cu wirebond package prior to reliability stress. No microcracking beneath PdCu ball bond.

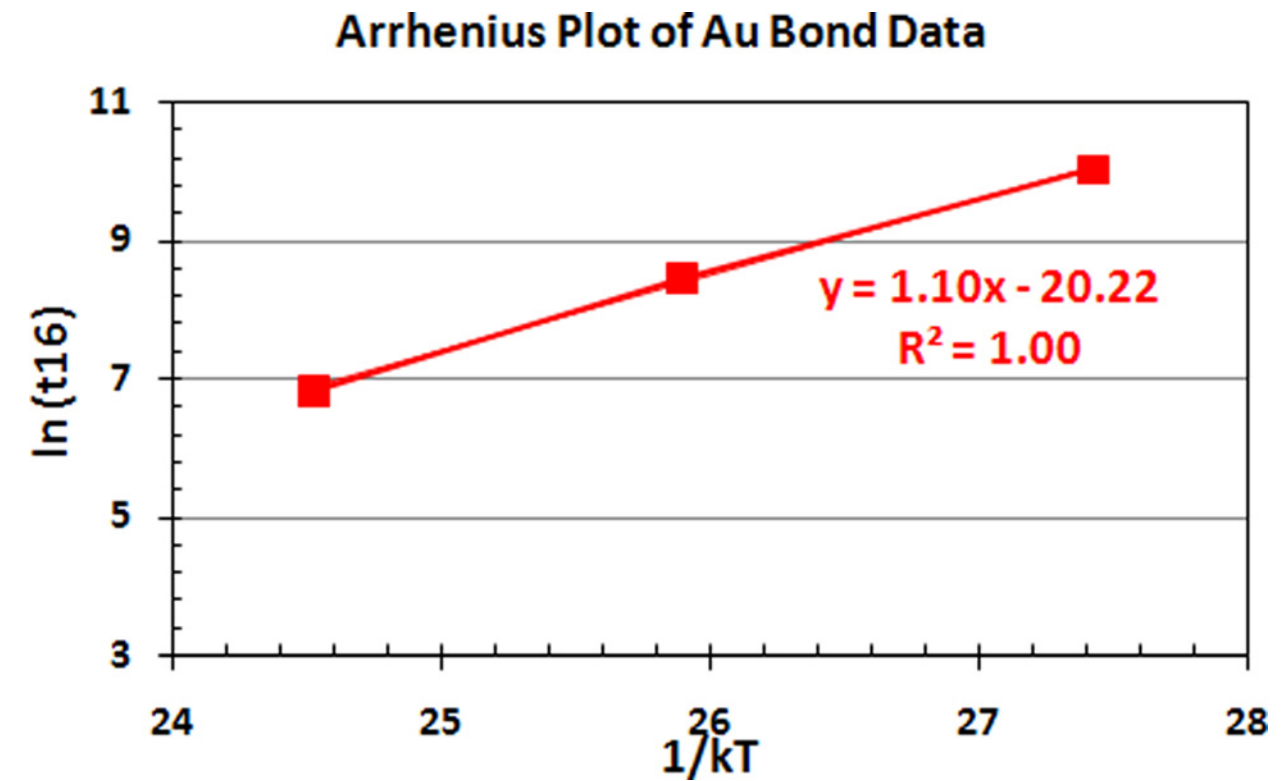
Fig. 9 Arrhenius plots of Au ball bond data against 1/*kT* aging time used in 110 nm semiconductor device

Figures 9 and 10 indicate the respective Au and PdCu ball bonds Arrhenius plots obtained in our measurement for 150 °C, 175 °C and 200 °C aging temperatures. It clearly indicates that Au atoms with higher Eaa for HTSL degradation, Eaa of 1.10 eV against 0.85 eV for PdCu ball bonds on 110 nm semiconductor device packaging.

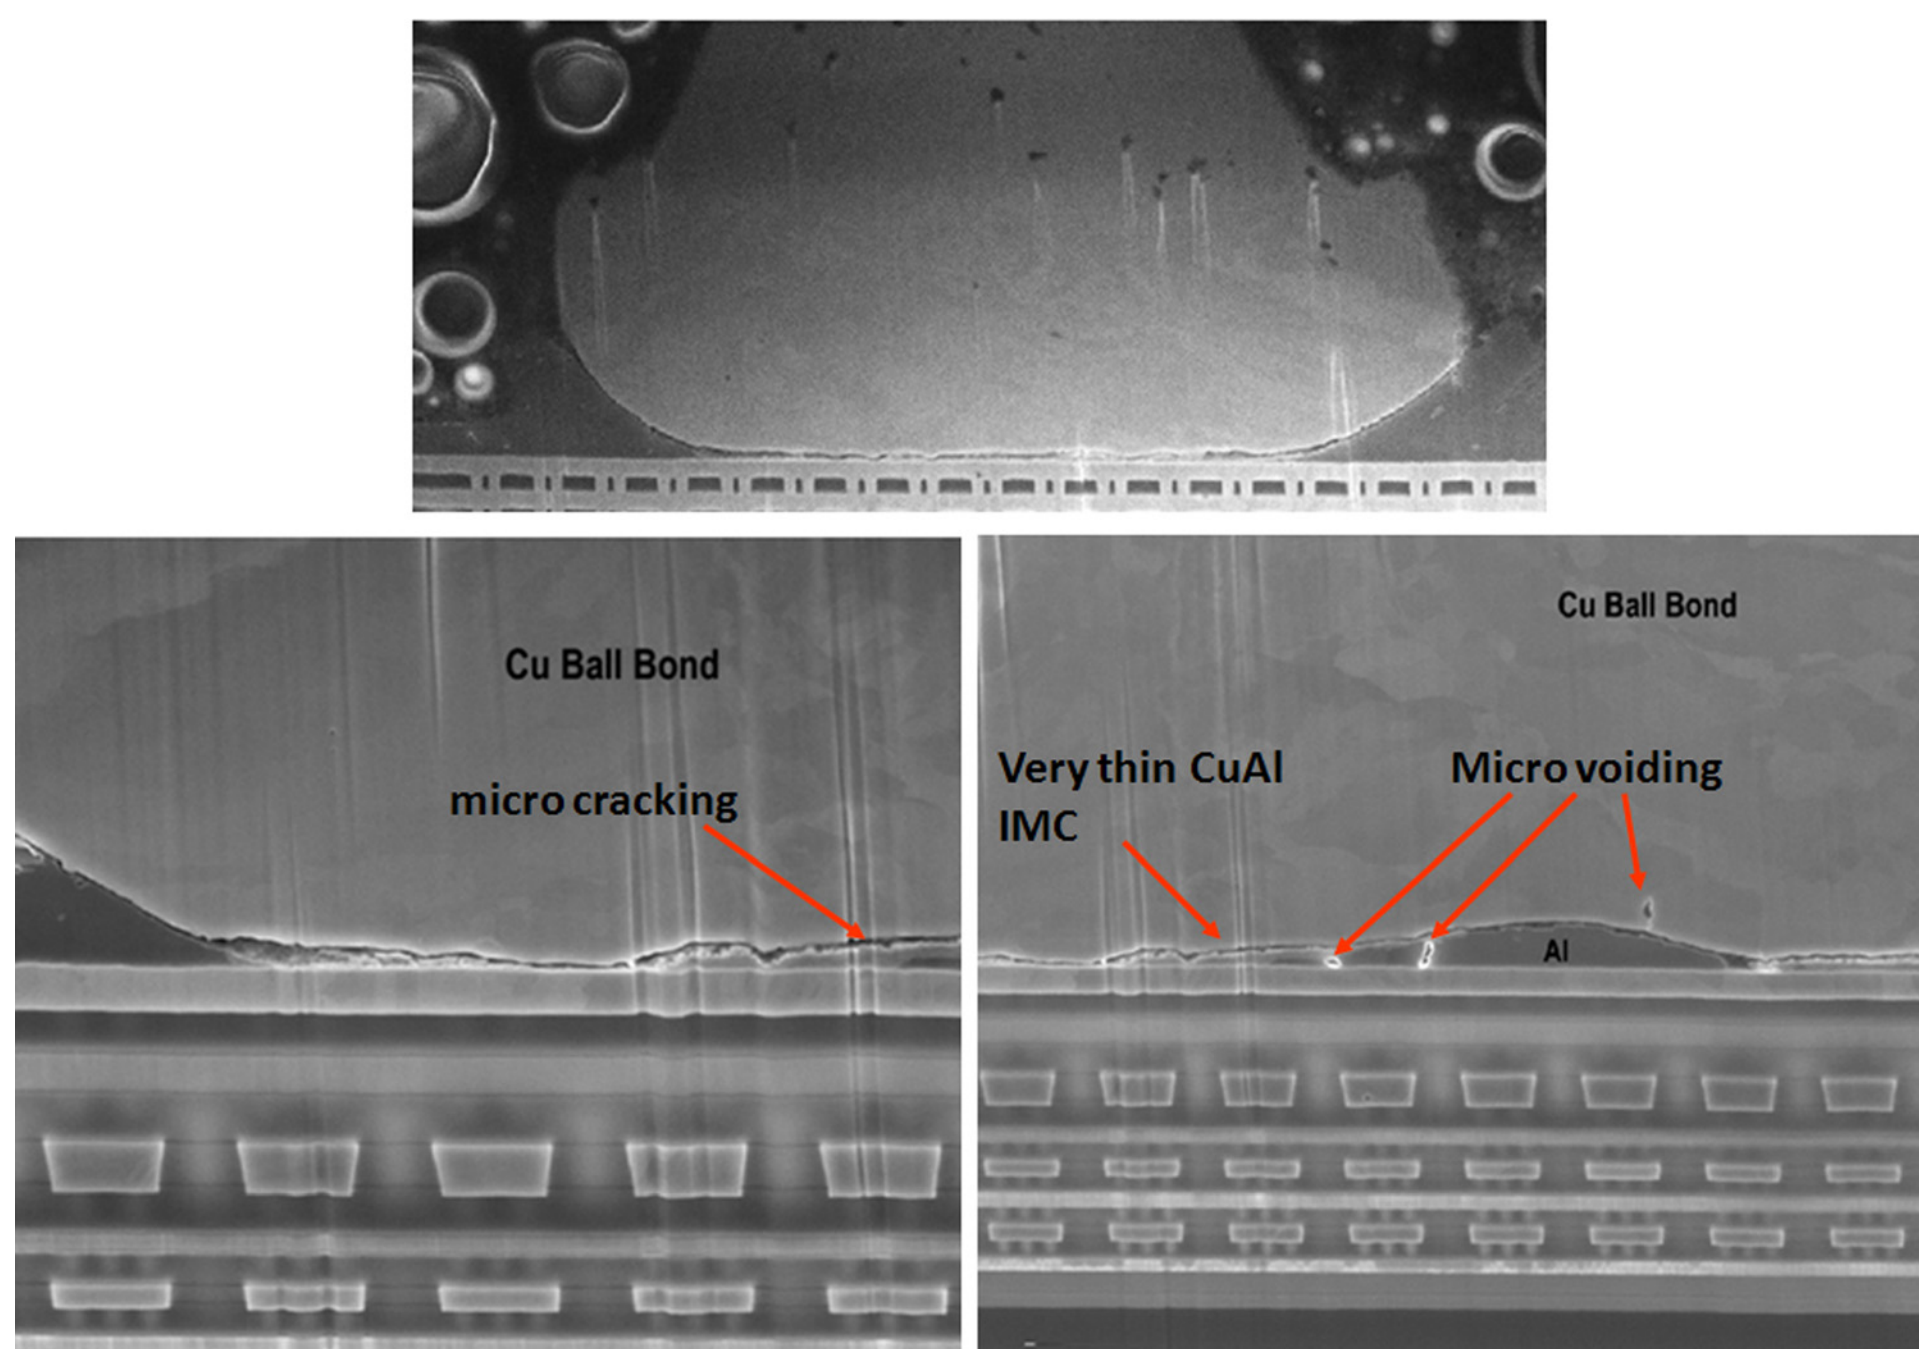
Cracking of the interface of Cu to the Cu IMC might be due to stress induce microcracking as a results of CuAl IMC oxidation (as shown in Eqs. (2) and (3)) in between Cu IMC to Cu ball bonds. Cracking usually starts at Cu ball bond periphery and will propagate towards center of Cu ball bond [1,3,8,12,16].

Representative PdCu ball bond cross-section SEM image confirms CuAl interface fineline cracking as shown in Fig. 8. The micro cracking would probably caused electrical opens in HTSL stress for PdCu. The failure mechanism of Au ball bond is found dissimilar to PdCu ball bond with similar fineline microcracking along the IMC region and caused opens.

Fig. 8 Typical CuAl IMC microcracks post extended HTSL stress (1500 hr, 200 °C aging). Signs of micro cracking and micro voiding are observed.

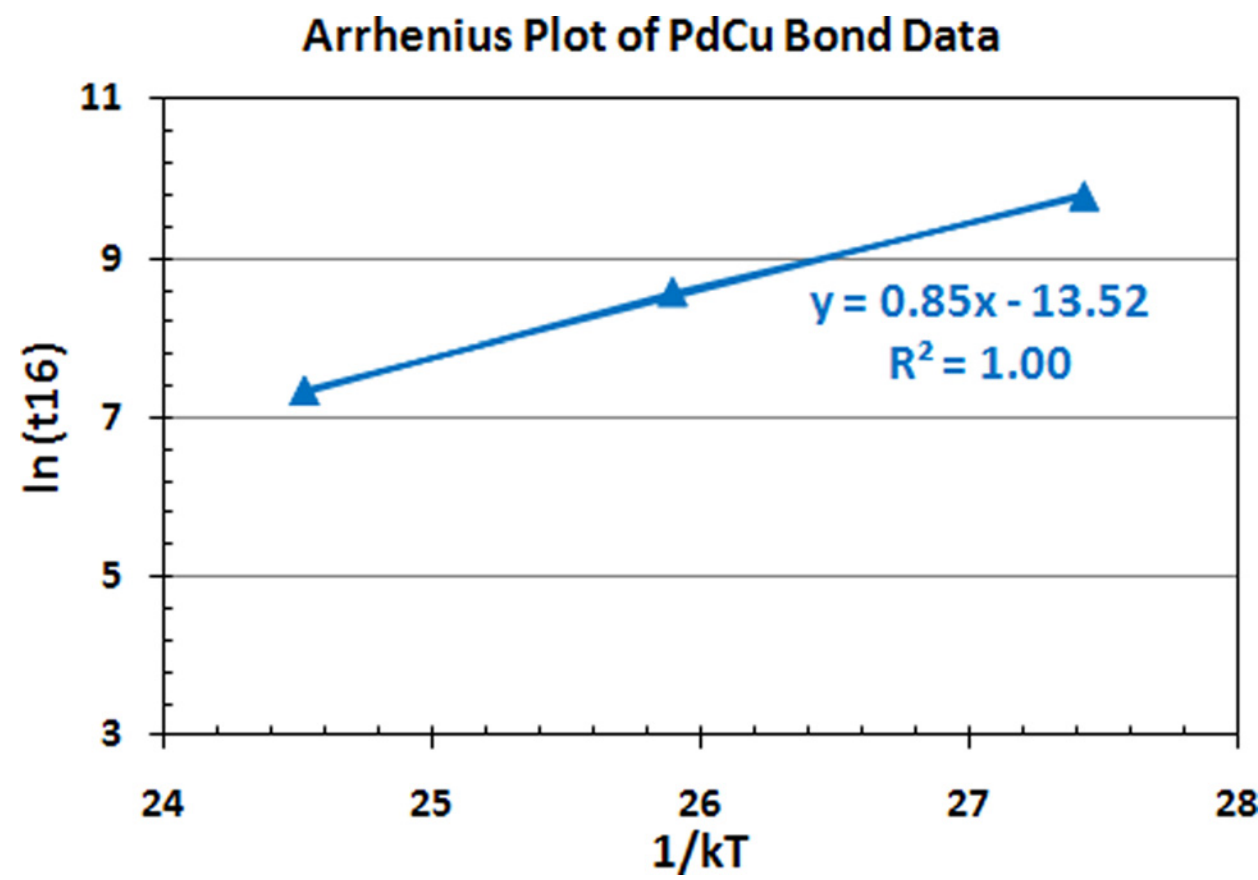
Fig. 10 Arrhenius plots of PdCu ball bond data against 1/*kT* aging time used in 110 nm semiconductor device

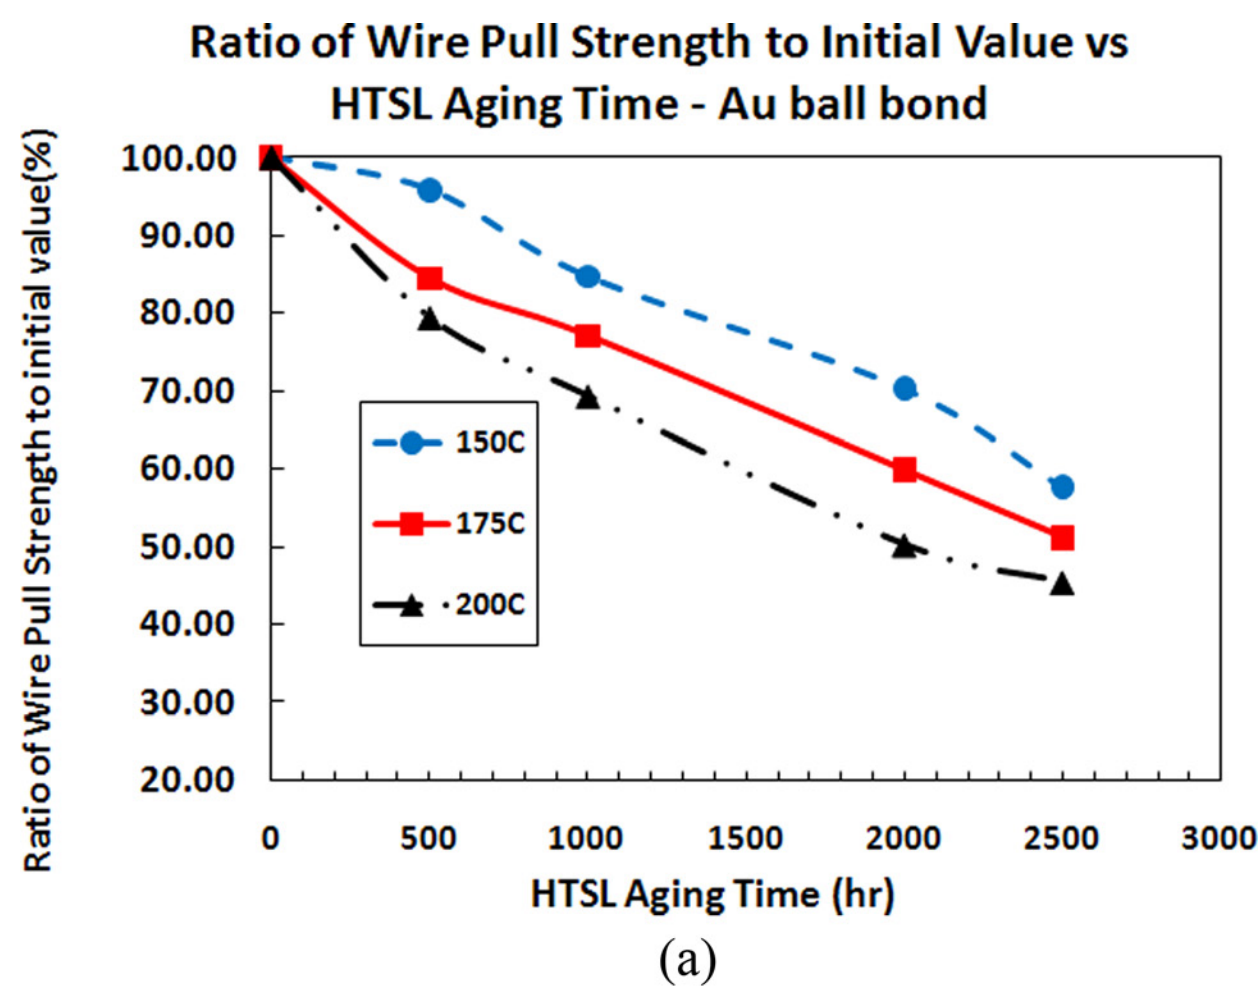
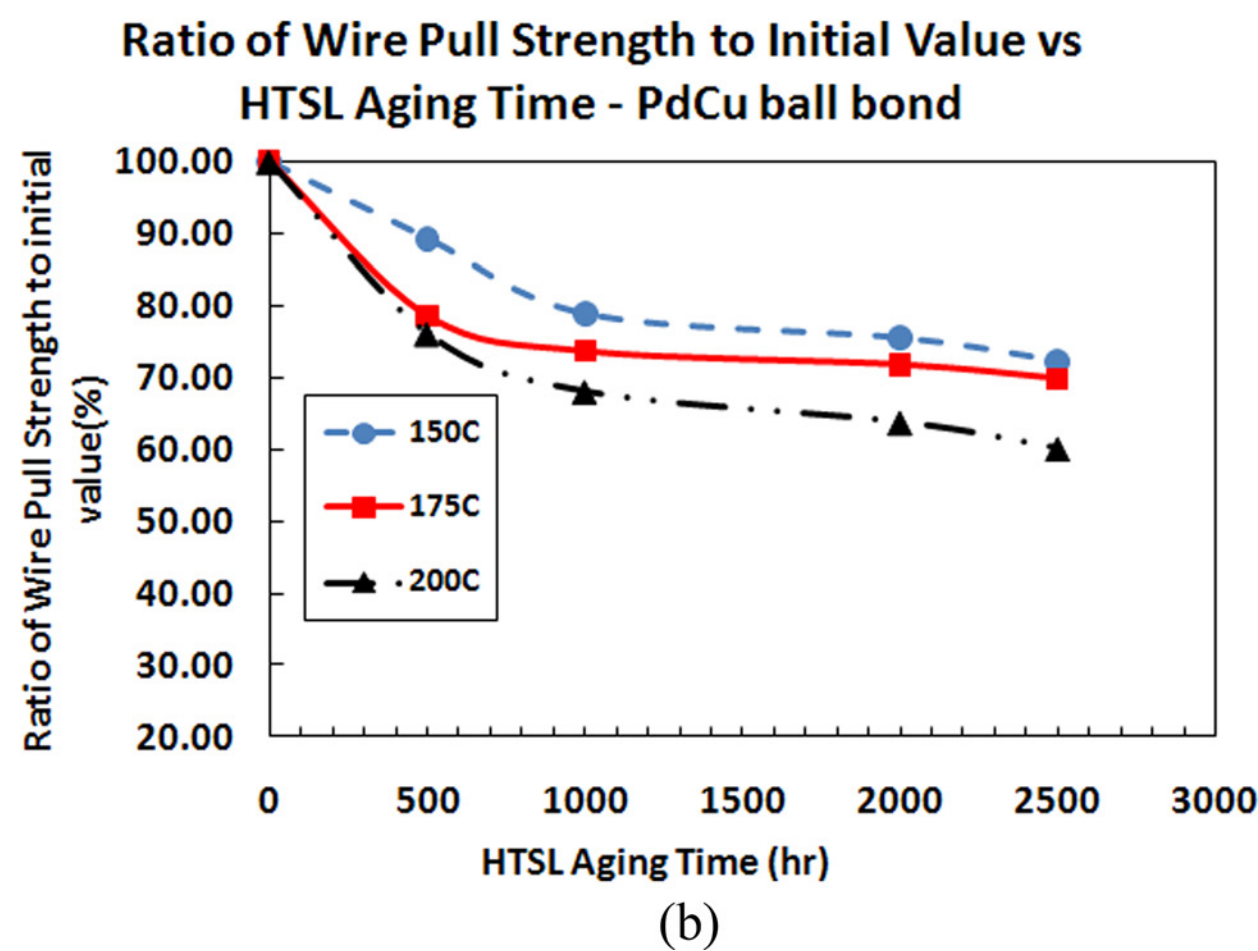
Fig. 11 Plots of ratio of wire pull strength to its initial value against aging time of various aging temperatures for (*a*) Au wire and (*b*) PdCu Wire

It is observed that the wire pull and ball shear strength of PdCu ball bonds degraded more than Au ball bonds after HTSL 500 h, 1000 h and 2000 h. However, it is still far exceeding the minimum shear and pull strength value of 14 g and 2.5 gf. In general, the magnitude of degradation is observed larger with incremental of aging temperatures from 150 °C to 200 °C (as shown in Figs. 11(*a*), 11(*b*), 12(*a*) and 12(*b*). Figures 12(*a*) and 12(*b*) indicate similar degradation trend for ball shear strength comparing Au and PdCu ball bonds. PdCu ball bonds exhibit faster degradation trend compare to Au ball bonds on 110 nm semiconductor device.

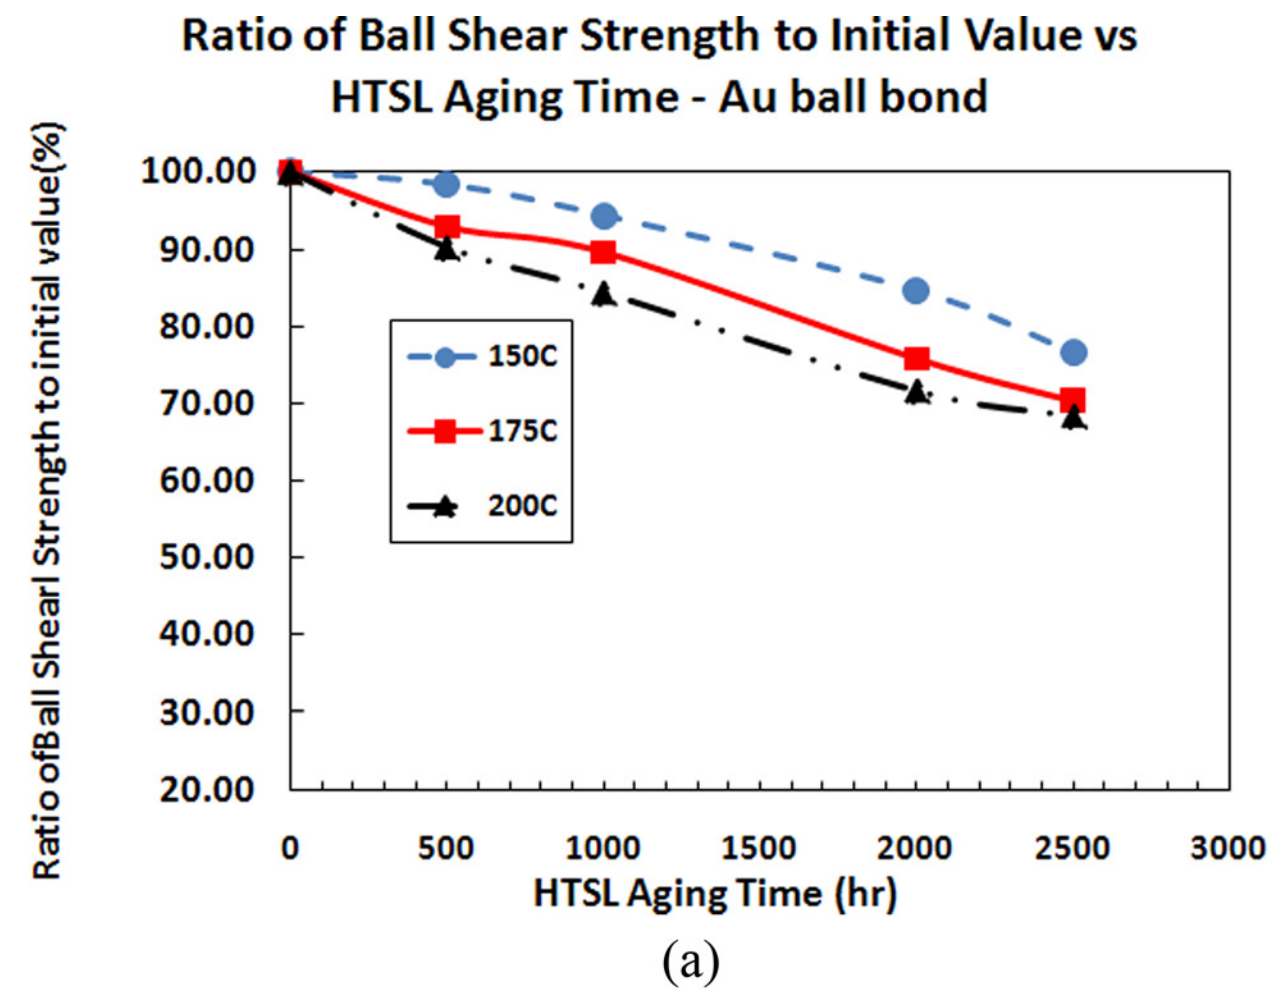
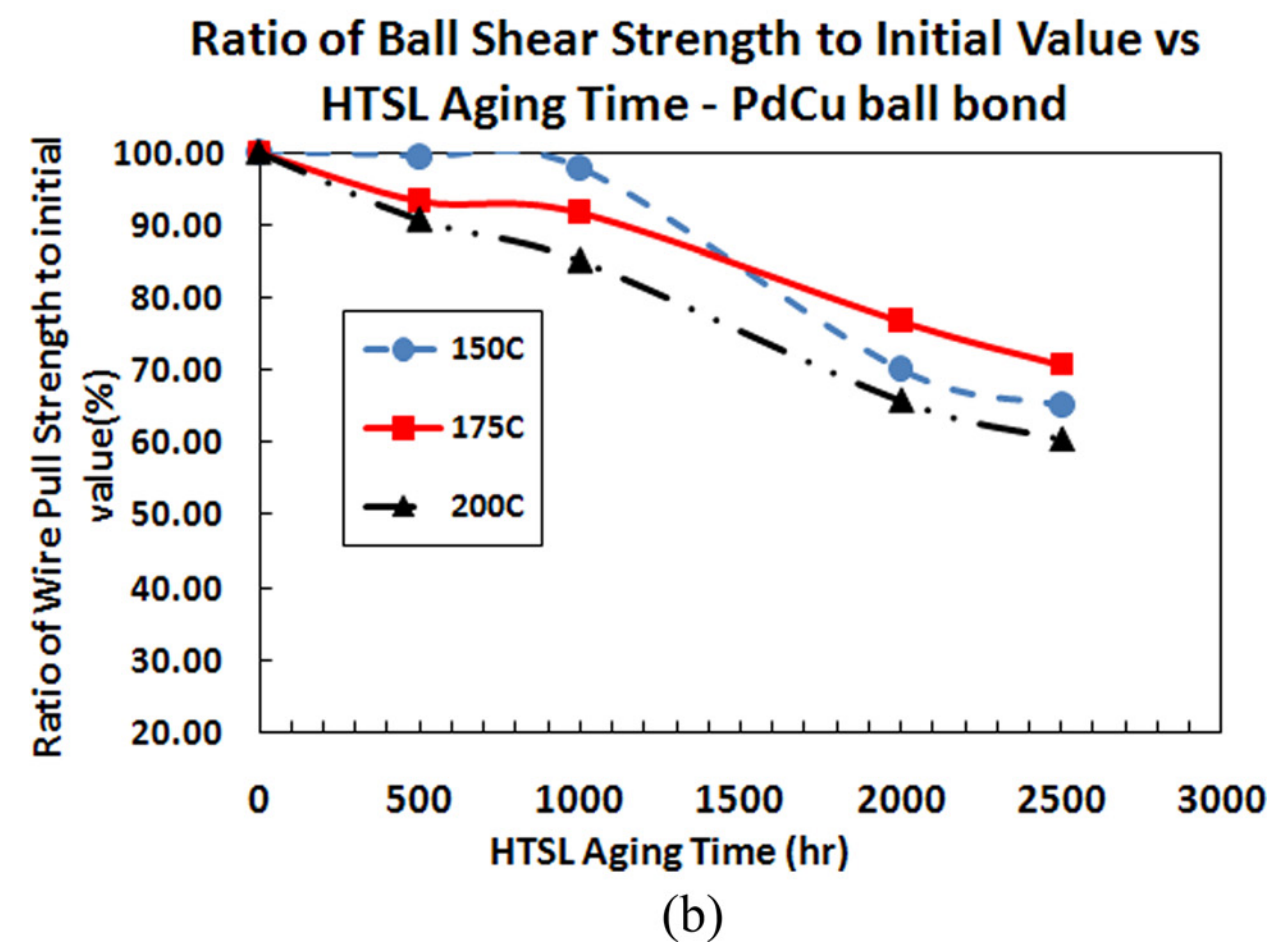
Fig. 12 Plots of ratio of wire pull strength to its initial value against aging time of various aging temperatures for (*a*) Au wire and (*b*) PdCu Wire
